### Investigation of the deterioration mechanisms induced by moisture and soluble salts in the necropolis of Porta Nocera, Pompeii (Italy)

# Investigation of the deterioration mechanisms induced by moisture and soluble salts in the necropolis of Porta Nocera, Pompeii (Italy)

This paper focuses on the diagnosis of damage processes of decorative Roman renders of a group of tombs in the Porta Nocera necropolis in the ancient city of Pompeii, Italy. Unprotected from various climatic events, the tombs keep on deteriorating since they were first excavated in 1954. Extensive on-site and laboratory diagnostics using non-destructive and low-destructive techniques have been able to demonstrate that soluble salts are among the major agents of deterioration, causing damage in the form of render delamination. Gypsum is formed on the surface of the materials by the deposition of sulfur dioxide, resulting in reduced porosity and hardening of the surface. Soluble salts of nitrates and chlorides that penetrate the tombs' masonry from the ground and are transported through the render layers tend to crystallize in subsurface. The crystallization—dilution cycles of the soluble salts cause major mech

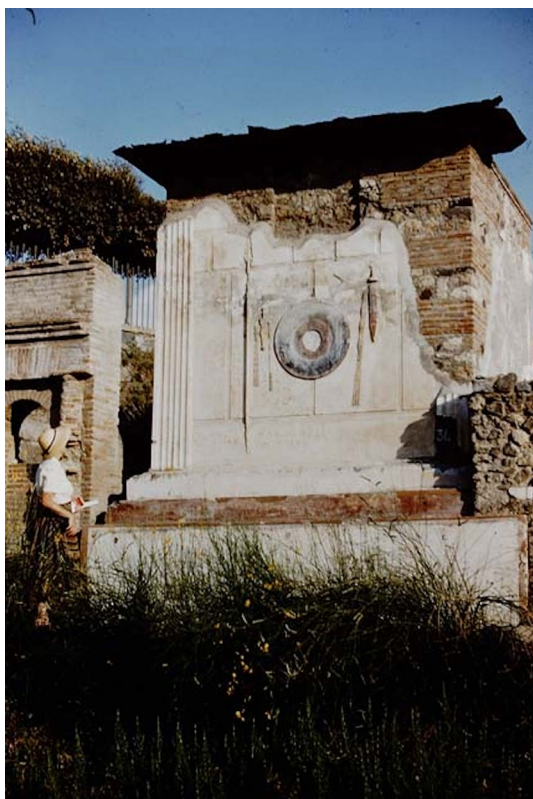
**Fig. 1** Tomb PN-ES13. Picture taken in 1959. Courtesy of Stanley A. Jashemsky

Photographs taken during or shortly after the excavation of the monuments testify to the good condition of most of them, with stucco render covering large areas of their masonry (Fig. 1). Today, some tombs have lost up to 90% of their decorative surfaces and every year, hundreds of grams of original stucco come off the walls (Fig. 2). Damage to mural paintings and ancient renders can have many different and often interacting causes. In the field of conservation of porous building materials, besides microbiological attack [4, 5], soluble salts are considered to be among the most important agents of deterioration [6]. Many studies in the archeological site of Pompeii

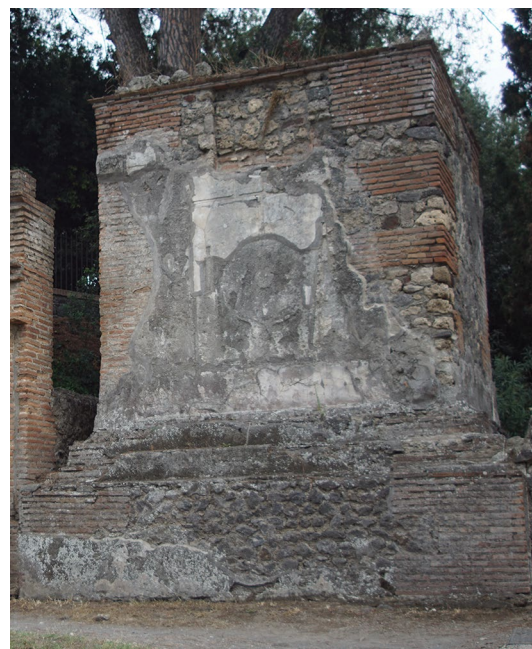
**Fig. 2** Tomb PN-ES13. Picture taken in September 2019

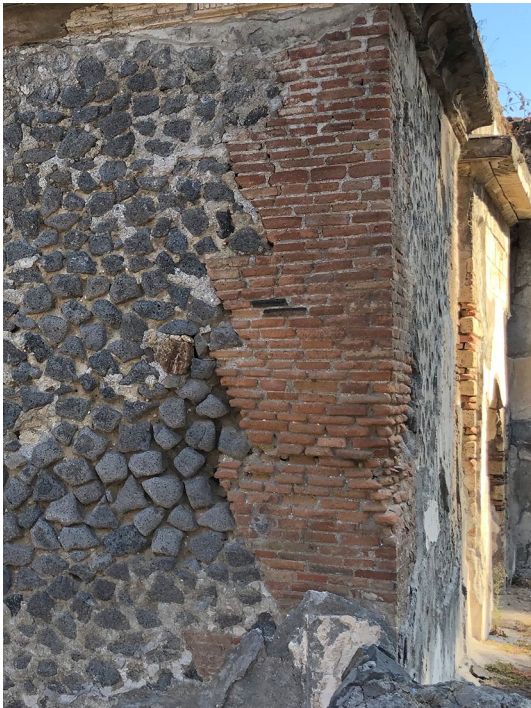
**Fig. 4** Tomb PN-EN10, west facade. Detail of the corner chain made of terracotta tiles disposed according to the "a vela" technique

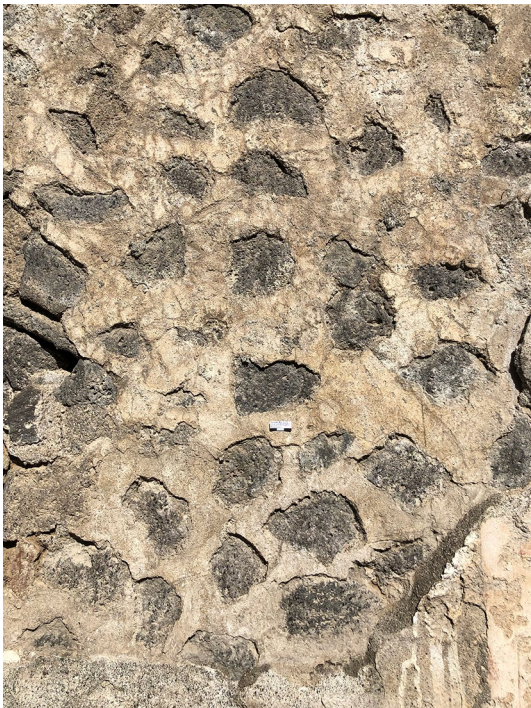
**Fig. 5** Tomb PN-EN10, south facade. Detail of the lava stone cladding mostly covered by the lime jointing mortar

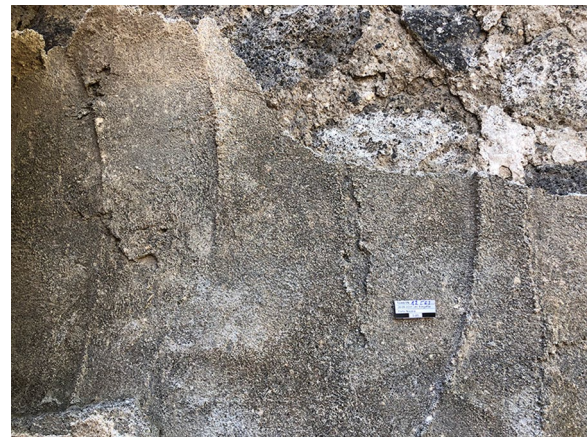
**Fig. 7** Tomb PN-EN12, east facade. Detail of the surface of render layer arriccio 0. Traces of the working tools left after the application of the mortar are clearly visible

Decay in the render allows us to observe how the render layers were applied. The first layer of *arriccio* was often applied very coarsely to fill the irregularities of the masonry. By looking at the tool marks left on the

surface of the mortar, it appears that the render layer was pressed against the wall using a trowel (Fig. 7). The pressure of the trowel brought the lime to the surface, leaving it binder-rich and smooth. The surface of the *arriccio* 1 render layer was applied in various thicknesses depending on the areas, from 1 to 4 cm. The surface of the *arriccio* 1 layer has generally been leveled with a float, to get a flat surface in preparation for the *intonaco*. Here too, the finishing work pulled the binder out and reduced the porosity of the surface.

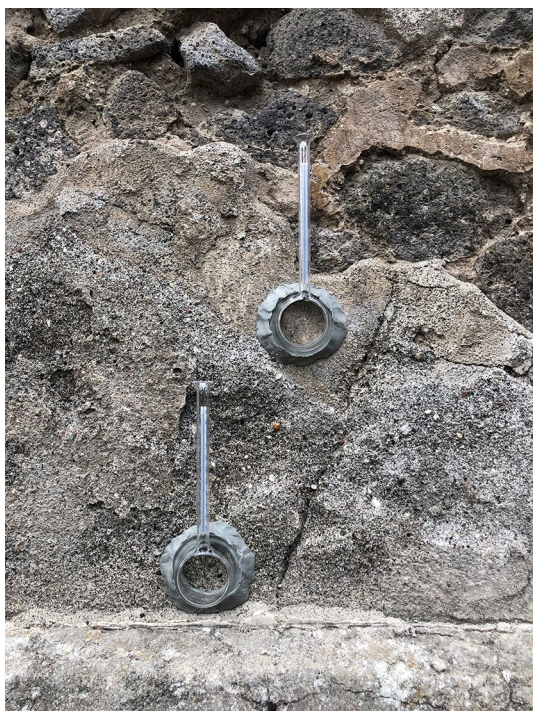
**Fig. 8** Measurements of Water Capillary Uptake using Karsten Tubes in the arriccio 0 and arriccio 1 render layers

A combined program of field and laboratory methods to define the water capillary uptake of the materials is set up. On-site, contact sponges method (CSM) and Karsten tubes (KT) are selected to measure vertical surfaces (Figs. 8 and 9) and impermeable basins for horizontal surfaces (Fig. 10). In laboratory, capillary water uptake measurements are carried out following the standardized test method DIN EN 52617 [27] on material fragments (Figs. 11 and 12).

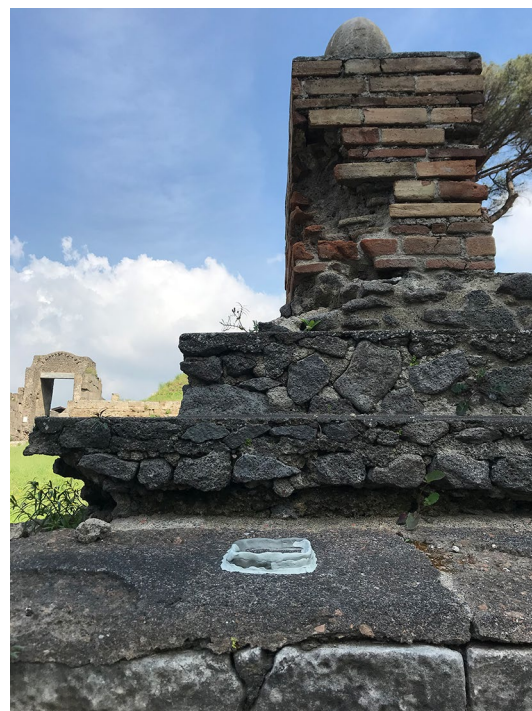
**Fig. 9** Tomb PN-EN02. Measurements of Water Capillary Uptake using basin method in the cocciopesto protective layer

Small basins of 25 cm<sup>2</sup> and 100 cm<sup>2</sup> using plasticine are created to measure water capillary uptake on horizontal surfaces of the tombs' construction materials. Measurements on horizontal surfaces are carried out to obtain data on the water uptake of the *cocciopesto* layer that should protect the top of the tombs to block rain-water infiltration (Fig. 9). As the *cocciopesto* layers presents deterioration patterns such as cracks and lacunas, measurements are also taken on horizontal surfaces of the underlying construction materials of the tombs,

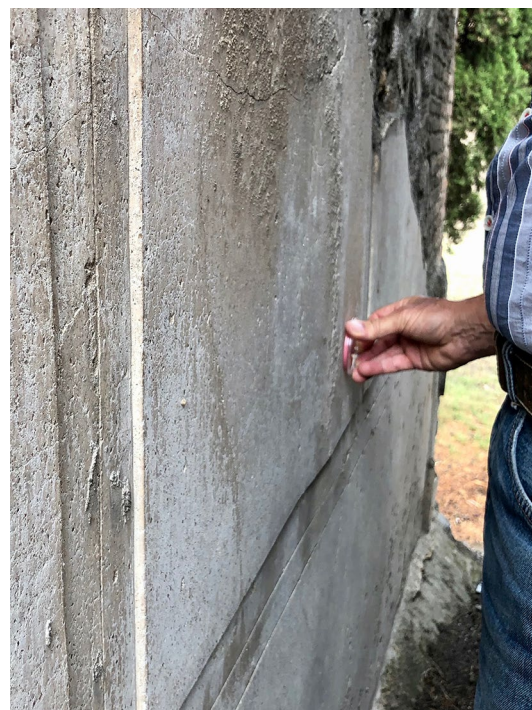
**Fig. 10** Tomb PN-EN12, East facade. Measurements of Water Capillary Uptake using Contact Sponges in the intonaco render layer

CSM measures are carried out on the surface on the intonaco and on the dense surface of the mortar of the joints from the tombs' masonry. In order to obtain a set of comparative results, several surface areas on the different tombs are measured. Measurements are taken on surfaces considered to be in good condition, i.e. without cracks or asperities visible to the naked eyes.

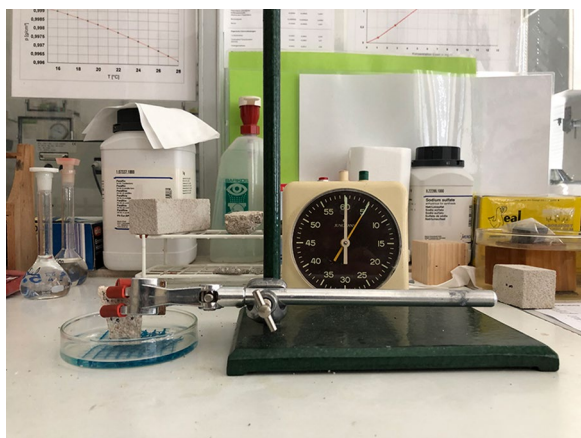
**Fig. 11** Measurements of Water Capillary Uptake on a sample of terracotta tile, according to DIN EN 52617

**Fig. 12** Measurements of Water Capillary Uptake on a sample of intonaco render layer, according to DIN EN 52617

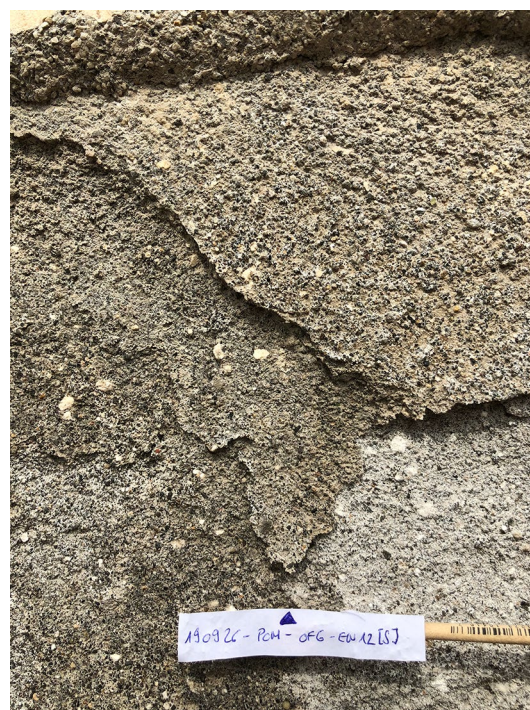
**Fig. 13** Tomb EN12, south facade. Detail of the sampling area of the crust formed at the surface of the arriccio render layer

- Surface material samples are mainly taken from the weathering crust that has formed at the surface of render layers and masonry on the south facades of tomb PN-EN06, 10, 12 and 14 (Fig. 13). The samples are firstly visually analyzed under a Leica M205C microscope. The hygroscopic moisture content (HMC) according to standard ÖNORM B 3355 [32].

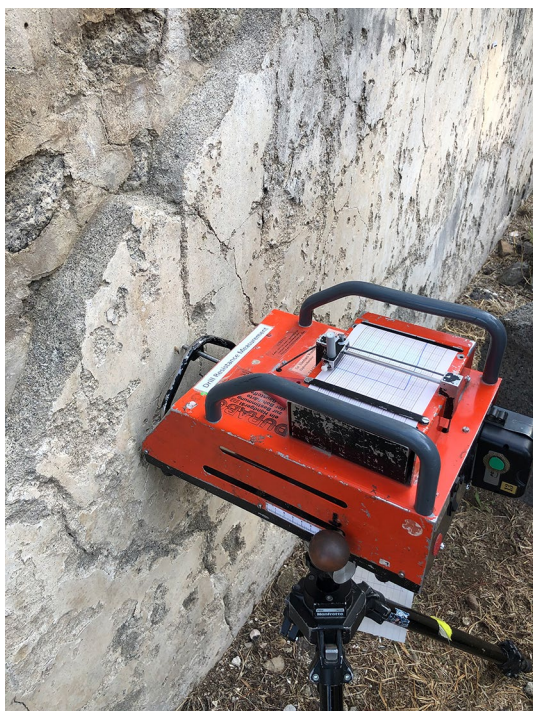
**Fig. 15** Tomb EN14, south facade. Area of sampling of powder material and of drilling resistance measurement using the apparatus DURABO®

- Drill powder samples are taken in several areas, chosen according to the degree of deterioration and the values given by the capacitance moisture meters. The drillings are undertaken with the use of a drilling resistance apparatus DURABO® with the aim of comparing the mechanical resistance of the material in relation to the quantitative salt load at different heights and depths (max 38 mm deep) in the south facade of tombs PN-EN14 and PN-EN06 and the north facade of tomb PN-EN04 (Fig. 15). The samples are qualitatively and quantitatively analyzed in laboratory by the determination of hygroscopic moisture content (HMC) according to standard ÖNORM B 3355 [32]; of electrical conductivity using a Hanna® HI 9033 device; and by the use of a spectrophotometer DR600 UV–VIS from Hach®. The spectrophotometer allows to detect only the anions of the salt mixtures present in the samples. The analyses are conducted in the laboratory (sampling time: September 2019).

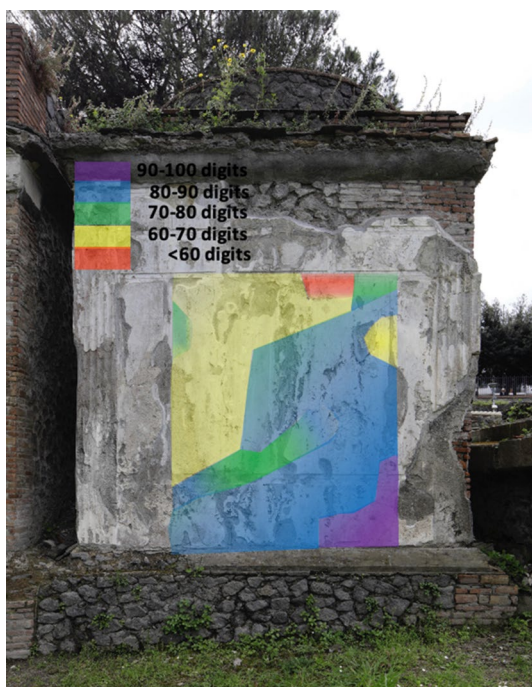
**Fig. 16** Tomb PN-EN14, south facade. Survey of moisture distribution using the device Gann Hydromette Compact B. Each range of value (in digits) corresponds to a color (see legend)

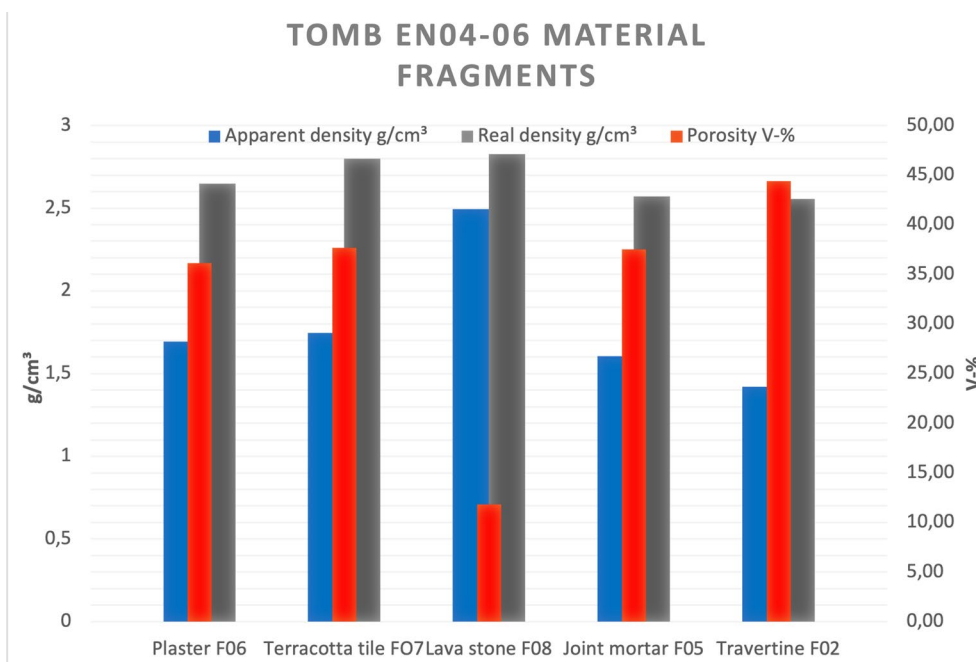
**Fig. 18** Apparent density, real density, and effective porosity in relation to samples of material fragments

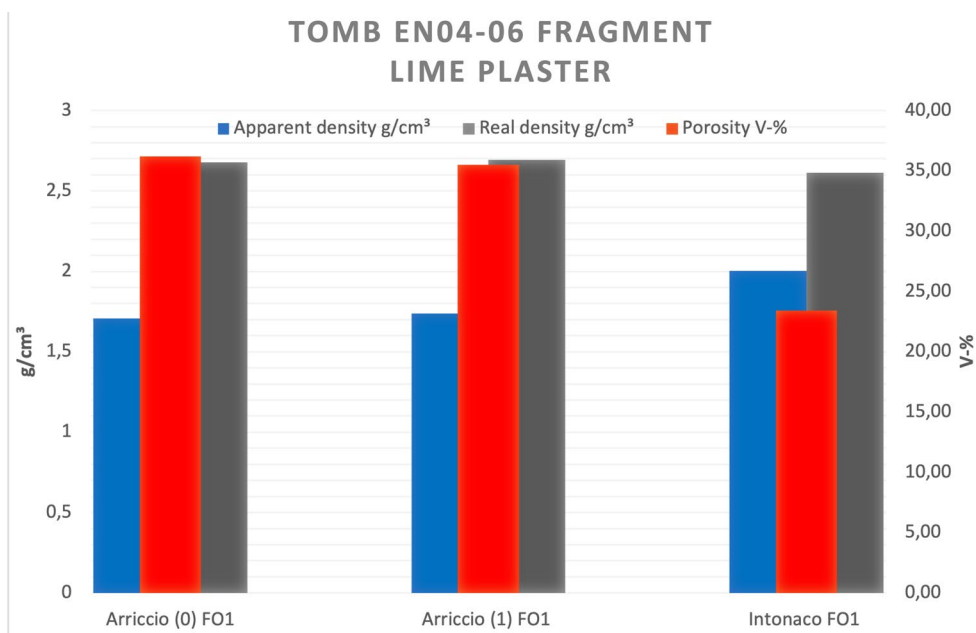
**Fig. 19** Apparent density, real density, and effective porosity in relation to samples of render layers

Concerning the render layers (Fig. 19), results show good compatibility between both *arriccio* layers with an effective porosity of approximately 36% and the tiles, jointing mortar and travertine stone in contact.

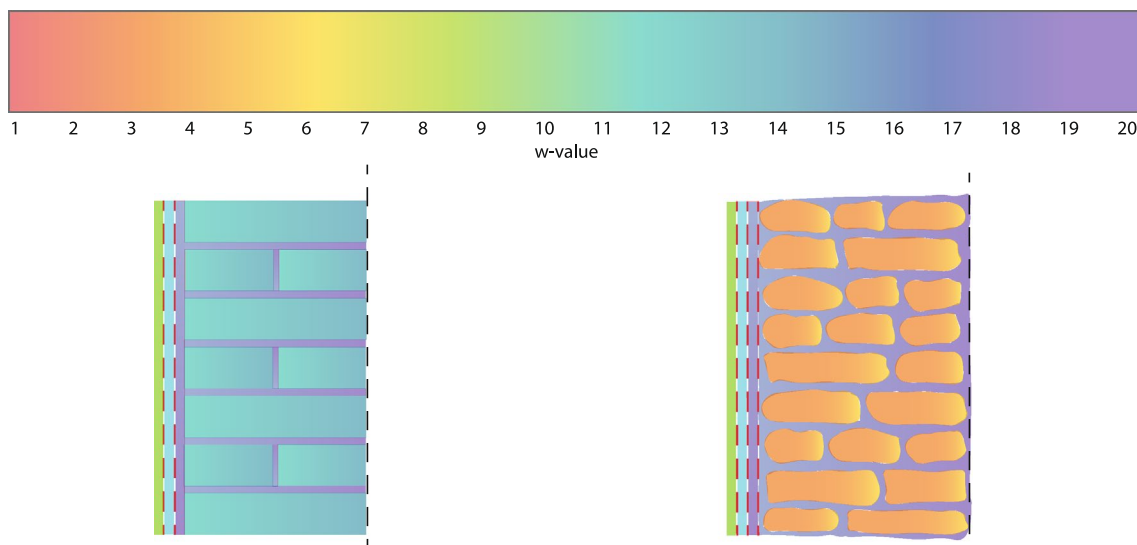
**Fig. 20** Left: vertical section in brick masonry. Right: vertical section in lava stone masonry. The materials are colored according to the w-value. The red dotted lines indicate possible water transport barriers

- The water capillary uptake measurements taken on-site show possible water transfer barrier at the interfaces of the render layers (red dotted lines in Fig. 20). This is suggested by the lateral spreading of the water when it reaches the underlying render layer. This lateral spread of water is due to the procedure of smoothing of the render layers, which has led to binder-rich and low porous surfaces. The same phenomenon is observed at the interface between the first preparing layer (*arriccio* 0) and the masonry of lava stones. This might be also due to the smoothing of the jointing mortar surface ( $w$ -value = 0.4 kg/m<sup>2</sup>h<sup>0.5</sup>) or the by the lower water absorption capacity of the lava stones ( $w$ -value = 2.8 kg/m<sup>2</sup>h<sup>0.5</sup>). Consequently, these water transfer barriers may lead to the accumulation of water between the render layers as well as at the interface between the render and the tombs' masonry in case of rain events. These interfaces may be preferential areas for the accumulation of soluble salts [34].

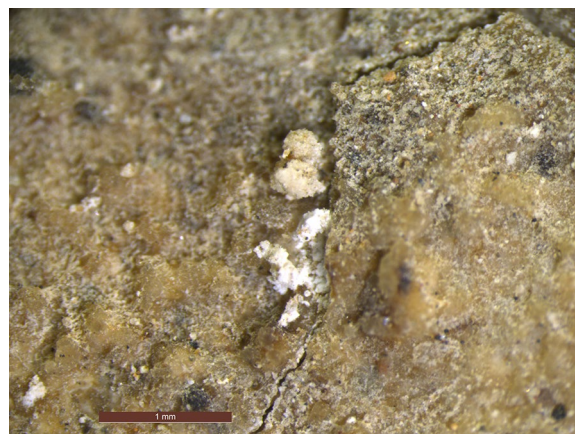
**Fig. 21** Detail under microscope of the gypsum crust at the surface of a sample of a brick from the facade south of tomb PN-EN06. The surface is bulged and cracked. White salt crystals from subflorescence can be seen in the crack

**Fig. 22** Detail under microscope of white salt crystals at the backside of sample of brick material (same sample as Fig. 18)

The observations of the surface material samples under microscope systematically show a thin to a thick salt crust at the material surface and the presence of salt efflorescence at the backside (Figs. 21, 22).

In Phase 2, hygroscopic chlorides and nitrates penetrate the tombs from the soil and come up into the masonries by capillary rise and recrystallization. These salts tend to accumulate in two horizons, located approximately between 50 and 90 cm and 150 cm and 250 cm from the ground (both horizons detected with NDT methods). However, most of these highly hygroscopic saline solutions might not cause noteworthy decay, as they would need an exceptionally dry climate for their crystallization [15]. On the other hand, non-hygroscopic sodium sulfate, certainly coming mainly from previous interventions containing cement, and accumulating as sub-florescence (Figs. 21, 22), can create high mechanical

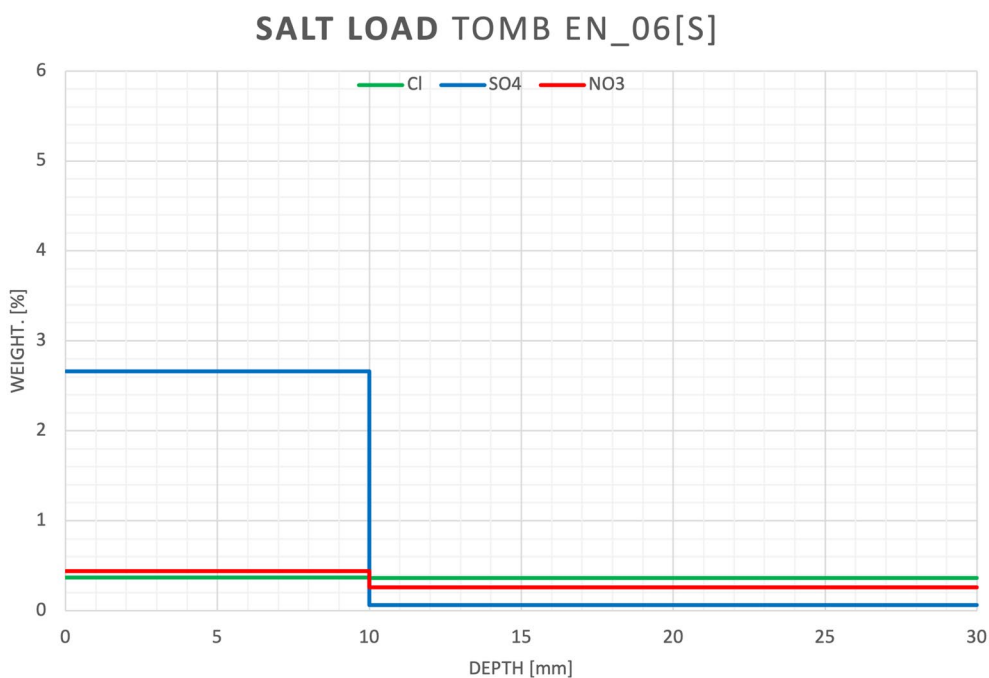
**Fig. 23** Salt load for depth-profile S4 taken in a brick from the masonry of tomb PN-EN06, facade south

high quantity deeper in the masonry between 10 and 40 mm (Fig. 23). In contrast, only low concentrations of soluble nitrates and chlorides are found in the depth powder samples taken in the render layers. This, despite the fact that the render surfaces show deterioration typically related to soluble salts. The measurements of drilling resistance taken while sampling the material powder show systematically detachments between the render layers, even from the masonry and the *arriccio* 0 and/or between both preparatory layers of *arriccio* and/or between the *intonaco* and the *arriccio* 1.

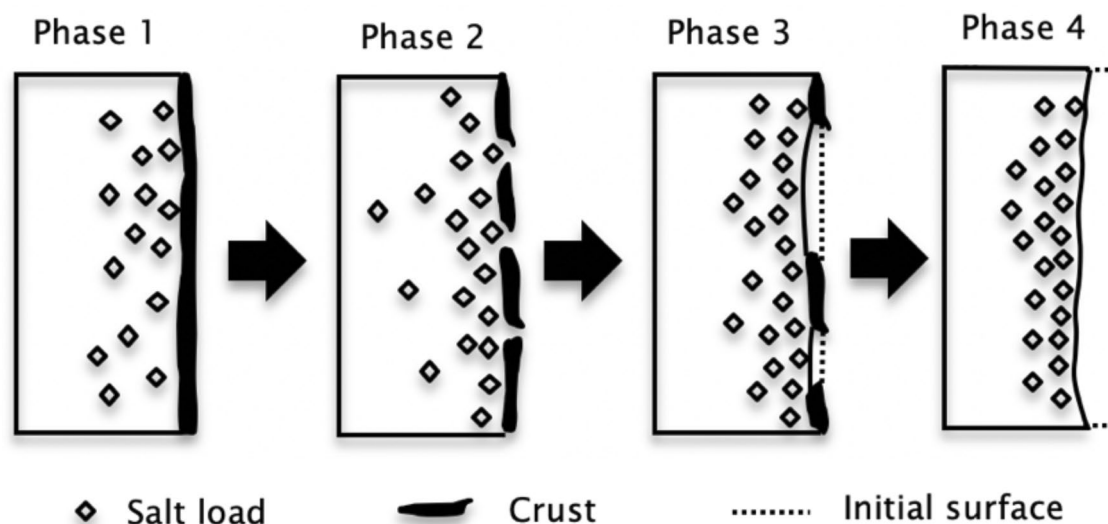
**Fig. 24** Illustration of the successive phases of deterioration that lead to the partial detachment of the material surfaces

develop in several phases, graphically illustrated in Fig. 24.

In Phase 1, gypsum aggregates at the surface of the building materials in contact with the atmosphere. It is formed by the transformation of calcite ( $\text{CaCO}_3$ ) contained in the joint mortars and renders into gypsum by dry or wet deposition (acid rain) of sulfur dioxide ( $\text{SO}_2$ ). For this transformation to take place, two key characteristics are necessary [35]. First, moisture must be available at or near the porous surface. Second, there must be an oxidation reaction to convert  $\text{SO}_2$  to sulfuric acid or to convert an intermediate sulfite salt to a sulfate (calcium sulfate dehydrate).

In Phase 3, the accumulation of soluble salts in sub-surface continues to cause surface detachment, leaving a more porous surface that has loss cohesion (sanding).

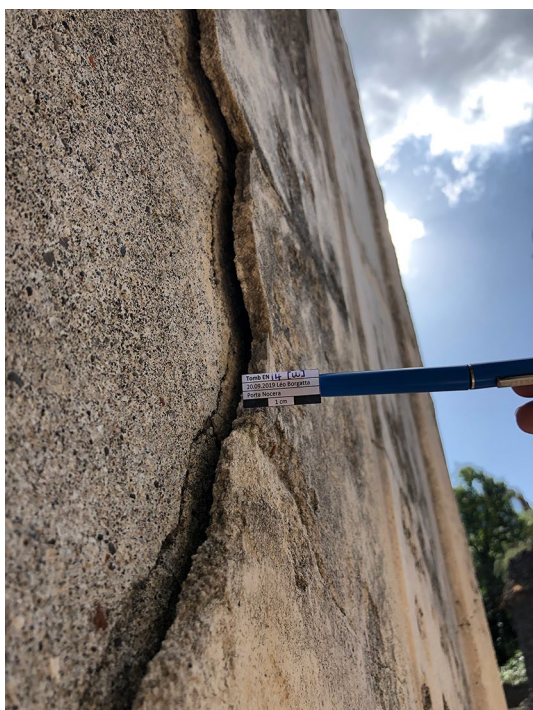
**Fig. 26** Tomb PN-EN14, west facade. Detachment of the intonaco render layer from the arriccio with ca. 0.5 cm gap
