# THE OCTAGON OF THE NIDAROS CATHEDRAL IN TRONDHEIM: CONSTRUCTIVE, HISTORICAL AND TECHNICAL STUDIES ABOUT ITS RESTORATION PROCEDURES UNTIL THE 19TH CENTURY

**KEY WORDS:** Nidaros Cathedral, Restoration, 19<sup>th</sup> Century, 3D-Scan, Mapping, Building Archaeology

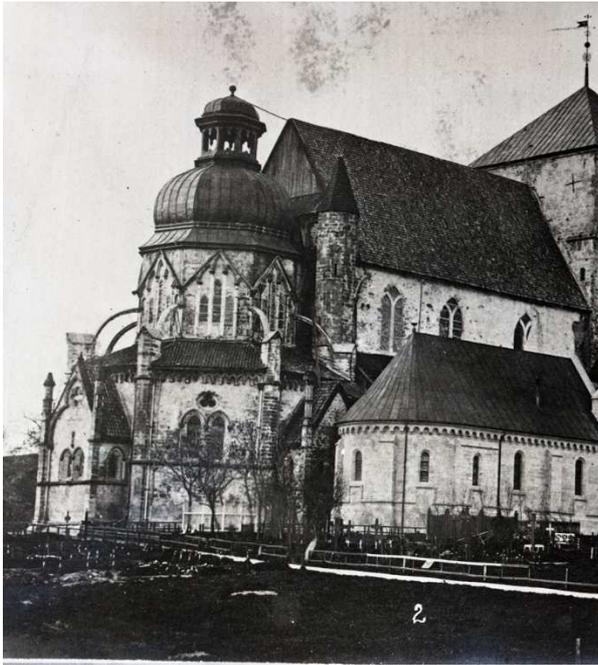
Figure 1. The Octagon before 1872; NDR Archive: Nr. 002

changes in its architectural forms, ornaments and fittings, with a dismantling of lots of its bays partial or completely due probably to a high degradation state, even if respecting highly the original design with the reconstruction process. The accurate extent of the dismantling through the mounting marks (Breitling, 2002; Ekroll, 2016), renovation and all other changes within the Octagon, thoroughly researched, stays yet undetermined. Already in 1531 though, few years after the renovation of Valkendorff, the whole city *Throndhjem* suffered another major fire. After it and the almost contemporary Reformation of Norway – with the consequent loss of significance of Nidaros –, the Cathedral was left to a slow but unstoppable degradation, with no proper reform or renovation measures. Even after later fires in 1718 and 1719 only inner changes (with new baroque fittings) and minor security measures were realized, among which a new onion roof instead of the burnt historical gothic spire over the Octagon was placed on 1722. (Fischer, 1965; Storemyr, Lunde, 1998) (Figure 1).

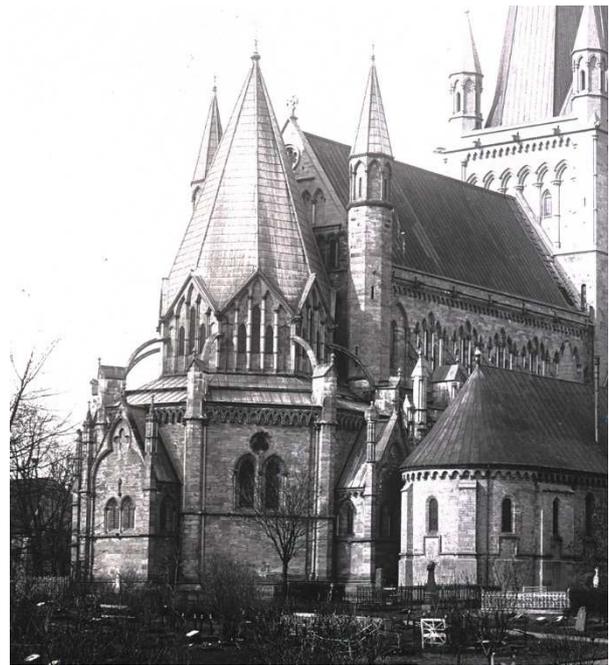
Figure 2. The Octagon after 1888; NDR Archive: Nr. 262

It was not until the independence of Norway from Denmark on 1814 that the first important architectural and archaeological investigations and measures on the deplorable state of the building were planned, which, during the 19<sup>th</sup> Century, would become the national monument of Norway *par excellence* (Lysaker, 1973; Duin, 1984; Danbolt, 1997). Already in 1869, the Restoration Office and Workshops *Nidarosdomen Restaureringsarbeider* (NDR) was founded, and early on 1872, the Cathedral condition would be explored so that its first architect, Christian Christie, could begin with a complete restoration, further building and completion of the Cathedral, and, with it, in its octagonal apse with a reconstruction of the historical spire, 1972–77 (Figure 2).

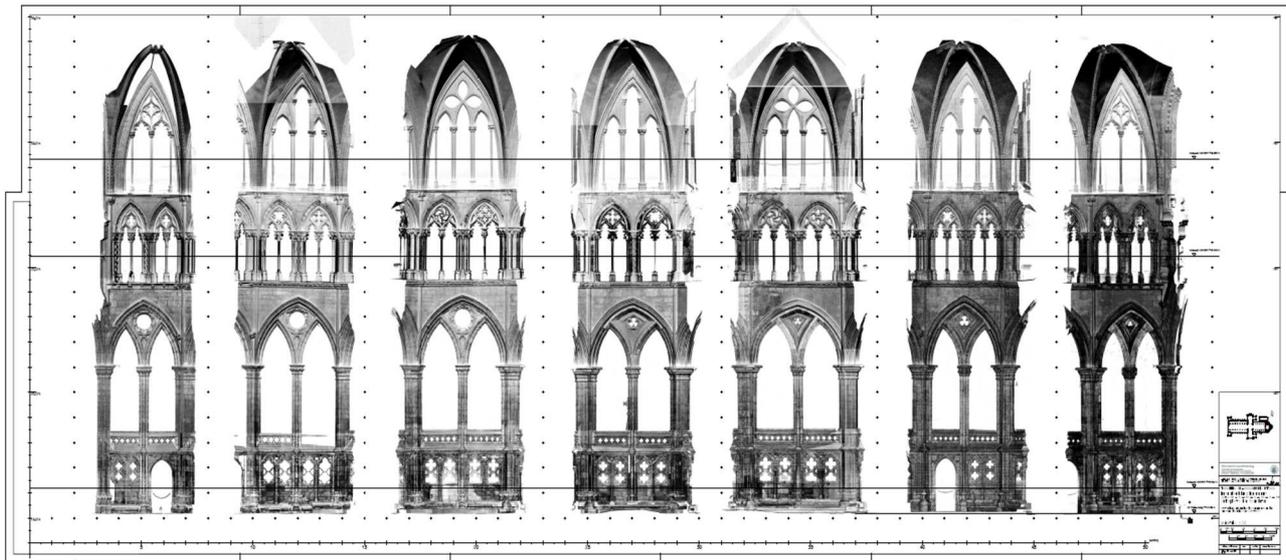
Figure 3. Inner elevation development of the bays NW, N, NO, O, SO, S, SW, except western Screen Wall (clockwise).

The complete archaeological analysis of the Octagon's seven bays and all these findings (exemplified in case of the North-Western bay in 3.2) has brought to the possibility to mark all the changed elements within both of these main restoration phases, in the 16<sup>th</sup> and 19<sup>th</sup> Centuries (Figures 9 and 10), comparing the situation with the mere orthophotos (Figures 3 and 4).

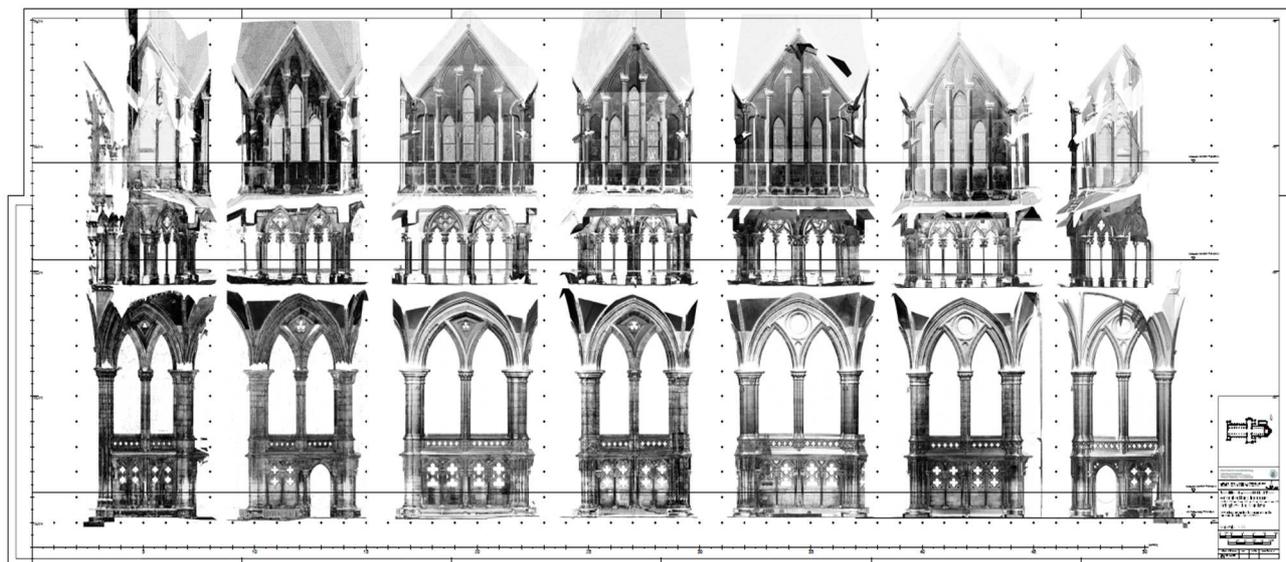
Figure 4. Outer elevation development (from deambulatory) of the same bays SW, S, SO, O, NO, N, NW (anticlockwise).

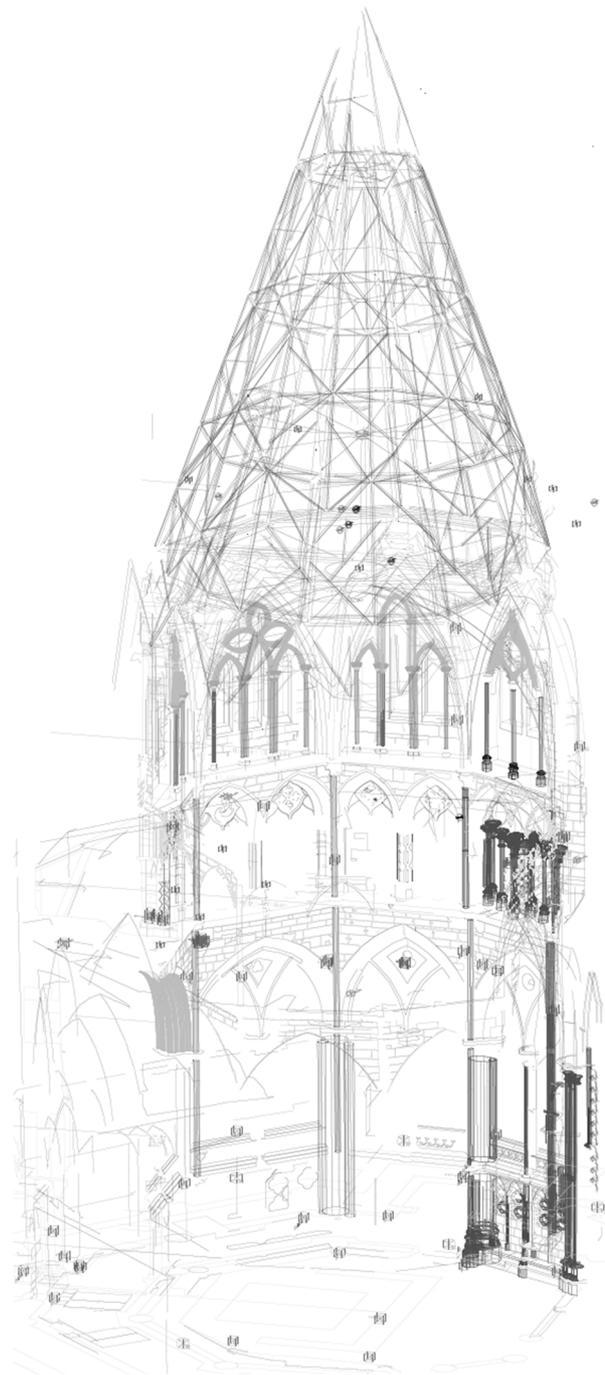
Figure 5. Tacheometrical measurement of the spire over the Octagon (Menargues Rajadell, 2014) merged with the 3D-tacheometrical Model (Breitling et al., 1999 – 2004).

measurement of the, until then, still absent area of the steel spire construction over the Octagon and the only partly measured vaulting from above (Figure 5).

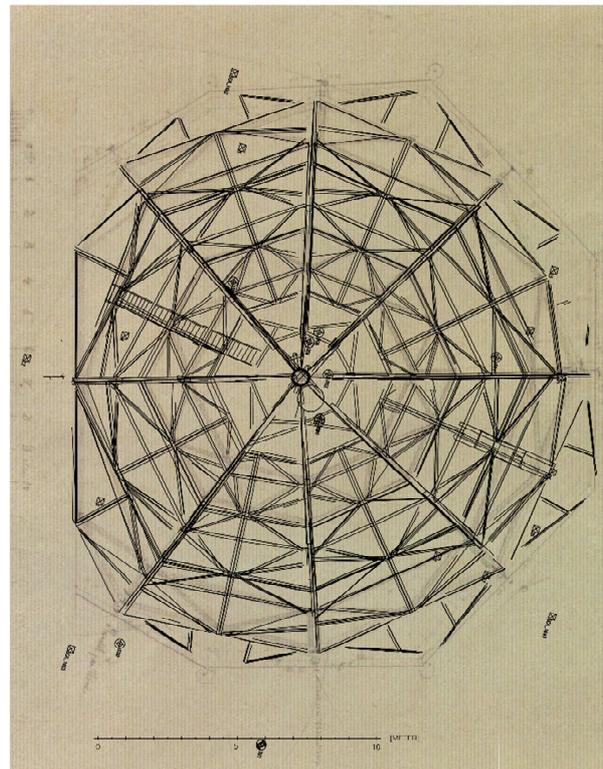
Figure 6. Superposition of the tacheometrical measurement of the author (Menargues Rajadell, 2014) to one of Christie's design floor plan (NDR Archive: Nr. 547)

Since the beginning of the research, the planning phase of the restoration measures has been thematized. The analysis of the historical planimetries, having been superposed, geometrically matched, to the tacheometrical measurements or orthophotos of the referenced 3D-Scan-based point clouds, have shown, on the one hand, that the accuracy of Schirmer's plans of 1859 (Schirmer, Munch, 1859), in a scale of 1:100, was reasonable, yet with measurement accumulated errors of ca. 8 cm. These were the basis for Christie's restoration, who certainly measured the building himself in order to prepare the restoration. A hint for this hypothesis can be seen in the measurements and detail representation plans of Christie's spire design, which are, on the other hand, much more accurate in comparison with the current building (Figure 6). Only minor changes or joint deformations among the metal profiles can be seen as an adaptation on site of the architect's plans.

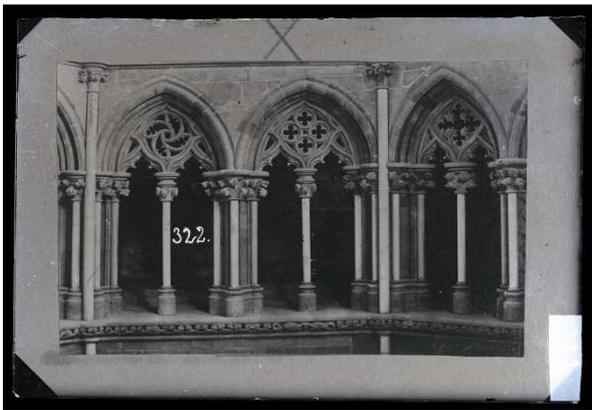
Figure 7. Condition of the North-East bay and half of the East bay after the restoration (NDR Archive: Nr. 322)

This so called *archaeological* restoration of Christie after the troubles with Schirmer's inventive approach could be especially seen in the comparison of the condition of the building and specifically in the architectural forms and ornaments before and after the restoration measure. A complete relation and reference between both periods has been realized, so that all differences could be marked in the main elevation developments, but also in each one of the historical photographs, so that every changed detail could be noticed and referenced (Figures 7 and 8).

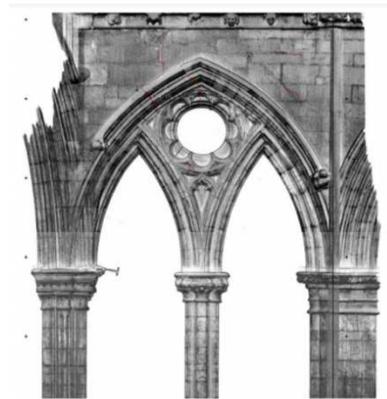
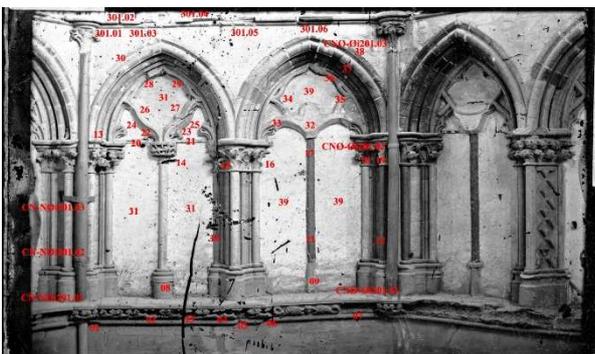
Figure 8. Condition of the North-East bay and half of the East bay before the restoration (NDR Archive: Nr. 186), with the referenced changes and restorations occurred.

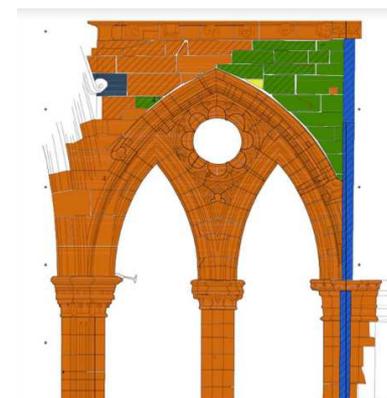
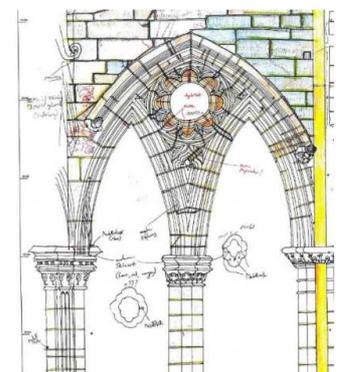
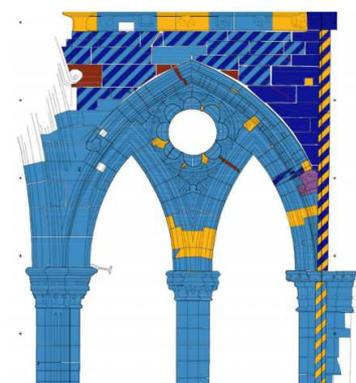
Figures 10-13, from above downwards:  
 Figure 10. Orthophotography  
 Figure 11. Material mapping  
 Figure 12. Sketch on site of archaeological findings  
 Figure 13. Construction phases (dark blue – before 1300;  
 light blue – 1328 phase; red – 1510/23 phase; yellow –  
 1872/77 phase)

Illustrating a deeper level of detail of this research, the North-Western (NW) bay of the Octagon has been redrawn in CAD-format, whilst mapping digitally all the findings found on site through the mapping extension *MonuMap (Kubit)*, connecting manually all further archival sources linked to it. The orthophotography (Figure 10), material mapping (Figure 11), sketched archaeological mapping on site (Figure 12), among many other mapping parameters, have brought to the result of the datation of all constructive elements (Figure 13). This, summarized in the main elevation developments (Figure 9, see next page) show the restorations of Valkendorff's period (in red) and of Christie's restoration (in yellow). Elements unbuilt (light colour), newly built (dark colour) or changed, restored or rebuilt (in stripes).

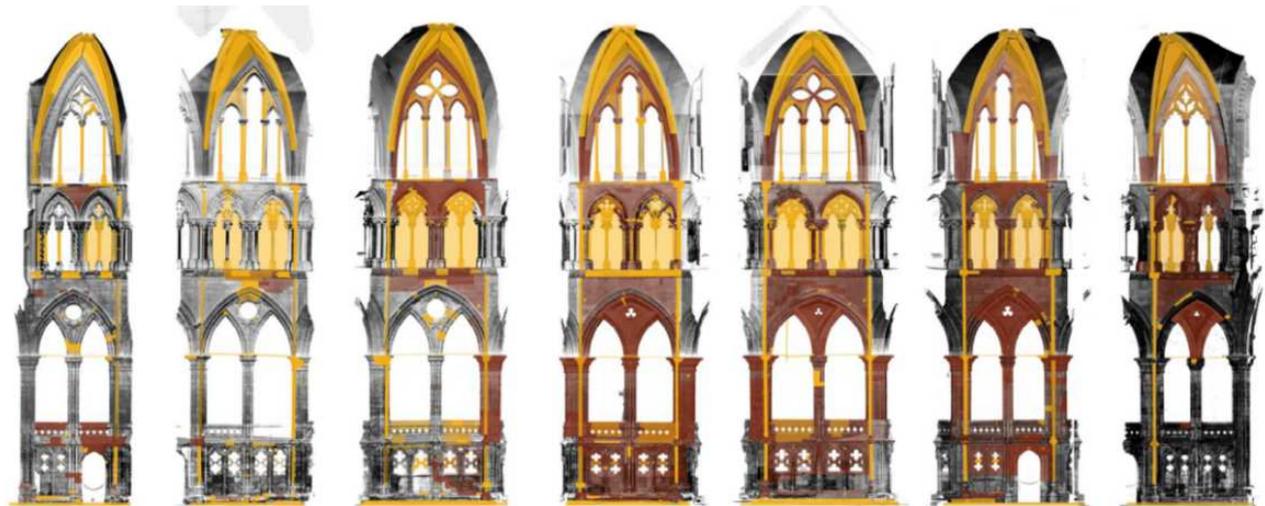
Figure 9. Inner elevation development of the bays NW, N, NO, O, SO, S, SW, except western Screen Wall (clockwise), with all the restoration measures detected through this research (in red-colours the ones from Valkendorff's period and in yellow the ones of Christie's).
