Structured Light Scanning as a Monitoring Method to Investigate Dimensional Changes Due to Climatic Changes on Cultural Heritage

Abstract: For a long-term preservation of cultural heritage items, stable climate conditions are necessary. As indoor temperatures will rise in the future due to climate change, chemical reactions take place much more quickly. At the same time, however, relative humidity decreases, which can cause damage, especially in the case of objects consisting of organic composite materials. As reactions to changes in climate depend very much on surrounding circumstances, on past climate patterns, and on the preservation history of an object (conservation treatments, changes in location, etc.), it is generally difficult to forecast future damage to cultural heritage objects that might be caused by climate change. Comparable damage patterns can be found on cultural heritage items which have been subjected to unfavourable climatic conditions over a longer period. This is usually due to excessive use, e.g., numerous events or the incorrect operation of cultural heritage items. This usually leads to inappropriate climatic conditions such as too high temperatures and to

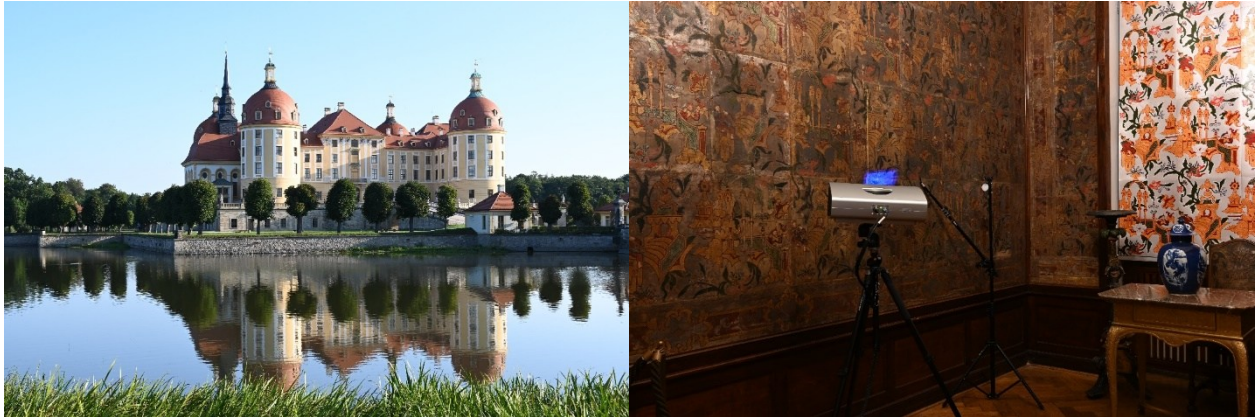
Fig. 1. Left: Castle Moritzburg from the 18th century is situated in Saxony 15 km north of Dresden. Right: The Chinese Room inside the castle is an example of one of 11 rooms showing original leather panels. The examination of the historic surface was conducted by structured light scanner combined with precise microclimate monitoring (© Kristina Holl).

The hunting lodge of Moritz of Saxony from 1542, which was converted into a baroque palace under August the Strong in the 18th century, displays the world’s largest collection of baroque gilt leather panels, see Figure 1. Eleven of the original 60 rooms in the palace still feature embossed, punched, and painted calfskin or goatskin panels, which are being continuously restored, see Schulze (1997) and Schulze (1998). As leather is an organic material that reacts very quickly and strongly to climatic changes, the leather panels in Moritzburg Castle suffer from high temperatures above 24 °C and a decreasing humidity down to under 30% RH. Typical damages are deformations, cracks as well as losses in the original substance. Especially leather panels which have been mounted in the past were fixed with nails and therefore are restrained. As a result, the reaction to fluctuations in temperature and relative humidity propagates especially around seams and mountings. For the examination with the SLS already damaged surfaces were chosen for investigation. Figure 2 shows the result of the SLS of the reference area in the Chinese room combined with an orthogonal colour photography, which was laid below to improve the localisation.

The measurements have been conducted with a COMET L3D 5M structured light scanner by Steinbichler Optotechnik (now Carl Zeiss Optotechnik) (Figure 1, right). With this method, it is possible to scan areas of varying sizes by changing the lenses. Using a 250 mm lens, an area of $260 \times 215 \times 140$ mm can be examined, and with a 75 mm lens, the area is $74 \times 62 \times 45$ mm. The distance between two measured points also depends on the lens: the smaller the image section, the higher the resolution (250-mm-lens: $100 \mu\text{m}$ distance, 75-mm-lens: $30 \mu\text{m}$). Using the Comet Plus 9.63 software, several scans are combined into a single data file. The scans were carried out in rows with a vertical and horizontal overlap of more than 50% between every single scan. The redundant data reduces the matching errors between the individual scans and guarantees a higher geometrical accuracy for each monitoring area (Figure 2, 3 right), see Drewello et al. (2011).

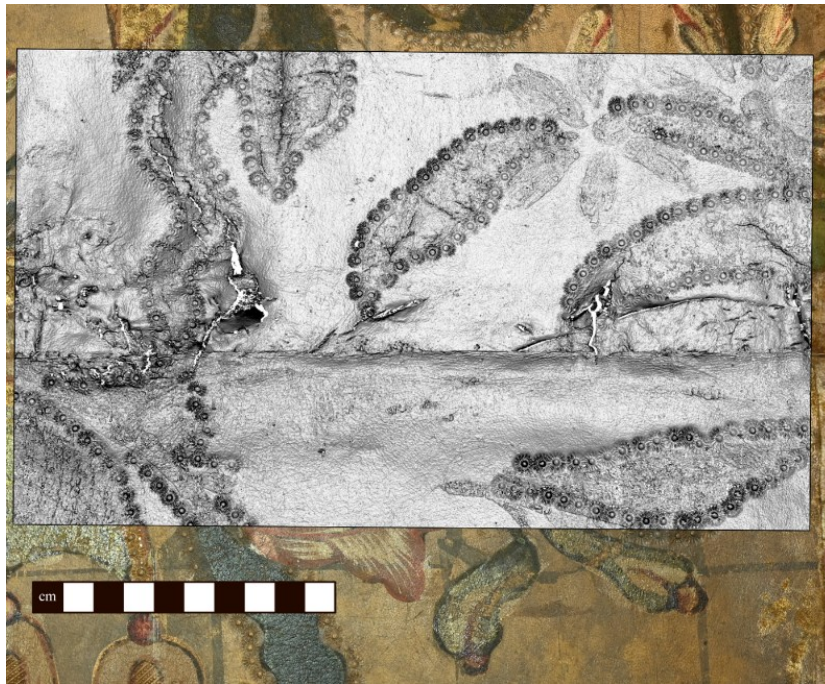
Fig. 2. Reference area of the leather panel in the Chinese Room in Moritzburg Castle taken by the SLS and laid on top of an orthogonal colour photograph. The grazing light increases the visibility of cracks and losses along the edge of two leather parts (© Leander Pallas).

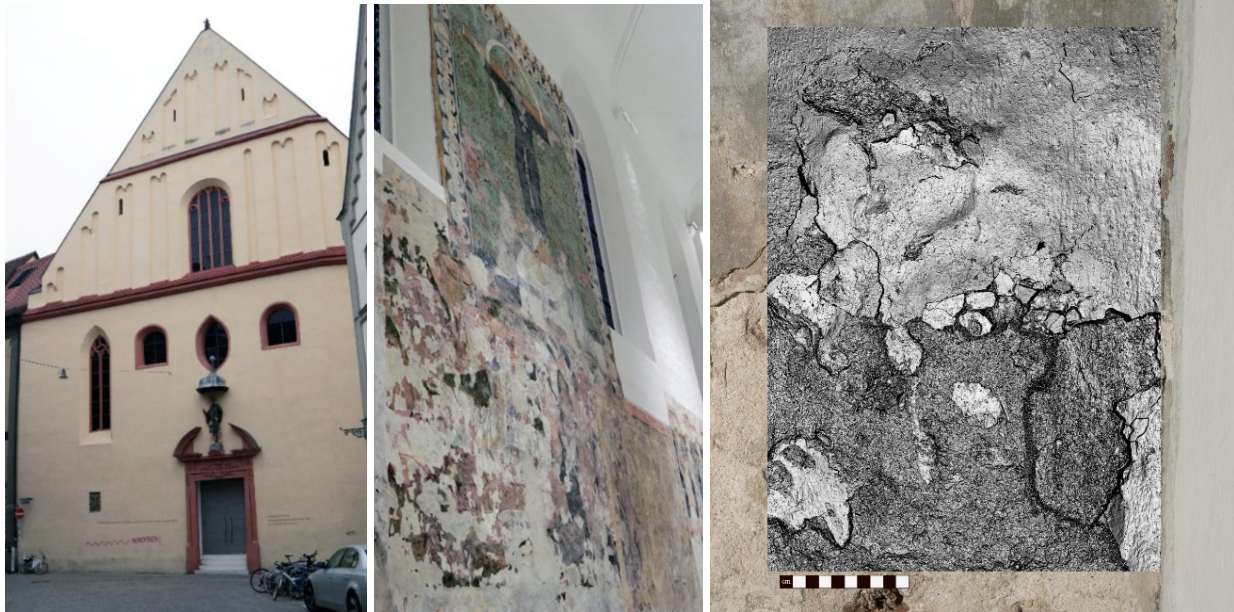
Fig. 3. Left: A street view of the former Dominican church of St. Christopher in Bamberg. Centre: Wall painting inside the former Dominican church showing a Volto Santo. Right: Reference area of the medieval wall painting taken by the structured light scanner laid on top of an orthogonal colour photography (© Leander Pallas).

The former Dominican church of St. Christopher in Bamberg in Northern Bavaria (Figure 3, left) is a large mendicant church from the 14th and 15th centuries. The church contains a large and complex program of wall painting fragments (Figure 3, centre), which have been uncovered successively during the 20th century, see Hoyer (2009). Extensively renovated between 1999 and 2015, a combined heating system consisting of an underfloor and circulating air heating was installed to use the former church as an auditorium for the University of Bamberg. During an inspection by Pallas (2020), fragments of the wall paintings flaked off and were found on the floor. Especially during the winter months measurements of the indoor climate showed extremely low relative humidity as well as high fluctuations of the relative humidity, see also Figure 4 right.
