Copy and paste? : A case study on a pair of jamb figures of the Fürstenportal Bamberg and their casts

COPY AND PASTE? A CASE STUDY ON A PAIR OF JAMB FIGURES OF THE FÜRSTENPORTAL BAMBERG AND THEIR CASTS

L. Pallas^{1*}, R. Tenschert¹, P. Bellendorf¹

¹Centre for Heritage Conservation Studies and Technologies (KDWT), Otto-Friedrich-Universität Bamberg, (leander.pallas, ruth.tenschert, paul.bellendorf)@uni-bamberg.de

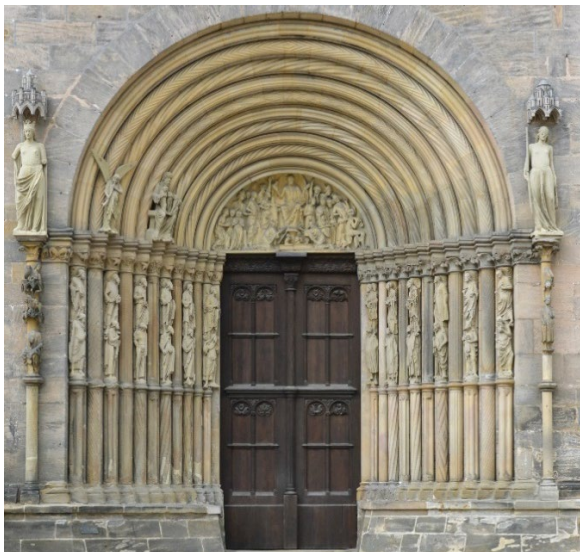
Figure 1. The Fürstenportal of Bamberg Cathedral.

The figurative representation of the Fürstenportal of Bamberg Cathedral of St. Peter and St. George (Figure 1), part of the Bamberg UNESCO World Heritage site, serves as a case study for preliminary research into this phenomenon. The predecessor building of Bamberg Cathedral was destroyed in a fire in 1185, and the construction of the new building began immediately after. The new cathedral was consecrated in 1237 (Exner, 2015, Hubel, 2015, Hartleitner 2011). The construction of the Fürstenportal itself was finished in 1225 (Breuer, 1993, p. 7, Exner, 2015, p. 424, p. 443) and is a round arched portal with a delicate figural decoration. The jambs are alternately decorated with eleven ornamented columns and column figures tapering inwards on each side, above the lintel is a scenically designed tympanon. (Albrecht, 2015, p. 243)

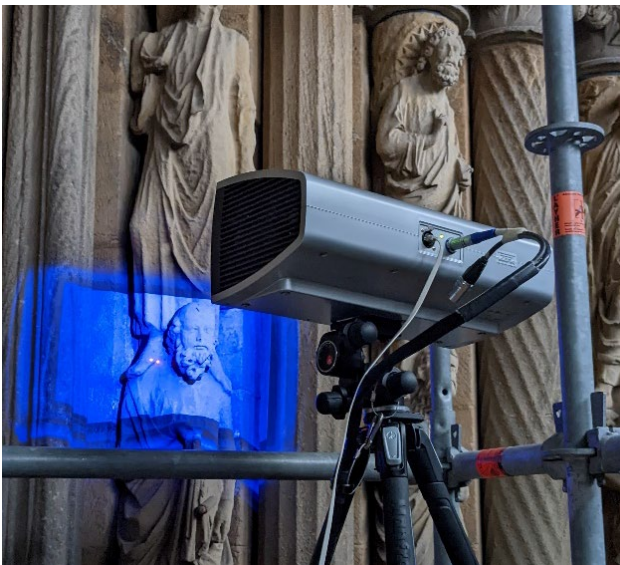
The SLS used is not handheld but it is portable, and thus can be used on site. The portability, and the use of a scaffold, enabled the scanning of the stone cast copies installed at the Fürstenportal without having to remove the figures (Figure 3). The measurements are completely contactless; in this case, there is only a projection of blue LED light onto the surface.

Figure 3. The Comet L3D 5M on a scaffold for the scanning of the stone cast copy.

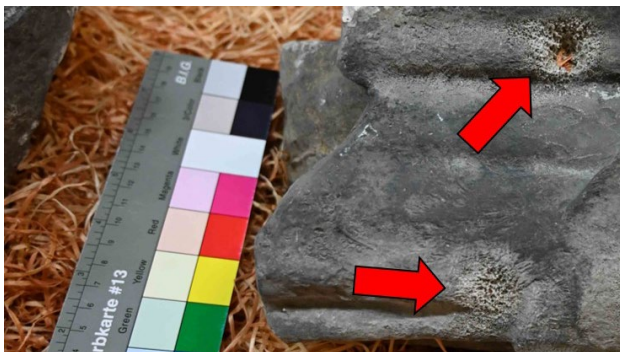
Since there were two different plaster copies of the same figure in the Diocesan Museum Bamberg's depot, the task was to find out which sculpture served as a model for the stone cast copies. Here the detailed mappings of the differences between the plaster casts and the originals were consulted. The considerations that led to the selection of a plaster model to be used for the stone casting were also noted. Since two plaster copies survived until the 1990s, a selection had to be made. This involved examining the two plaster figures for their fidelity to the original and recording any damage that had occurred during storage. This damage included, for example, breakages that must have occurred during transport, but also dripping damage caused by a leak in the roof (Figure 5). (Dauer et al., 1994)

Figure 5. Dripping damage on one of the plaster copies.
