### **Stone walls, characters, moss and trees : multilevel documentation of inscriptions and graffiti from different centuries in a former sandstone quarry**

## STONE WALLS, CHARACTERS, MOSS AND TREES – MULTILEVEL DOCUMENTATION OF INSCRIPTIONS AND GRAFFITI FROM DIFFERENT CENTURIES IN A FORMER SANDSTONE QUARRY

**KEY WORDS:** Graffiti, inscriptions, 3D-Documentation, weathering, stone decay, climate change.

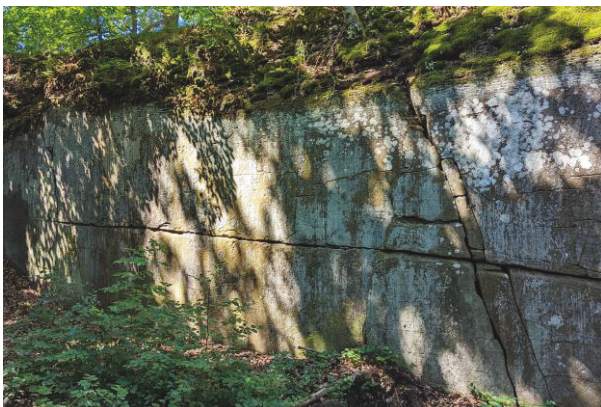
**Figure 1.** One of the sandstone walls of the quarry in July 2022, illustrating the challenge of moss and lichen.

The site is a decommissioned sandstone quarry, which has over the past several centuries, been gradually taken over by nature and the surrounding woods (Fig. 1 and 2). According to basic historical research, it is known that the site was still in use after the stone mining ceased: During the Thirty Years' War (1618-1648), and later from 1806 on during the Napoleonic Wars (1804-1815), the quarry served as field quarters for troops. There the soldiers carved many inscriptions and dates into the sandstone walls in both French and German. In the later 18th and 19th centuries, the site attracted visitors from the nearby castle, who found in this place an example of the wild landscape which was popular with the Romanticism movement at that time (Schultheiß 1986).

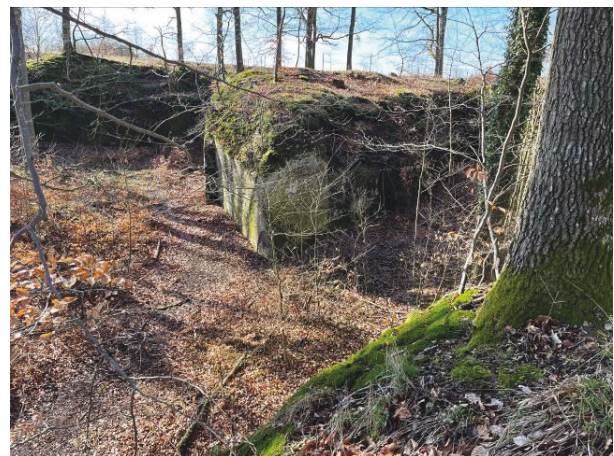
**Figure 2.** View into the area of the decommissioned quarry in March 2023.

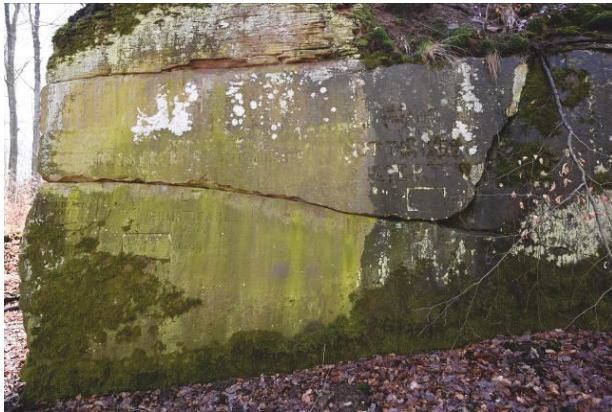
**Figure 3.** A stone wall of the quarry with graffiti and biological coating (moss, lichen, small tree) and water drainage traces especially on the right side.

The main problems of the stone walls in the former quarry are erosion, mechanical damage and biological colonization, as well as moist areas due to water drainage as categorised in the ICOMOS glossary on stone deterioration patterns (ICOMOS 2010). Some bigger parts have even spalled off in the last few years (Fig. 4). Therefore the inscriptions and graffiti in the area of the former quarry are thus slowly but steadily being erased.

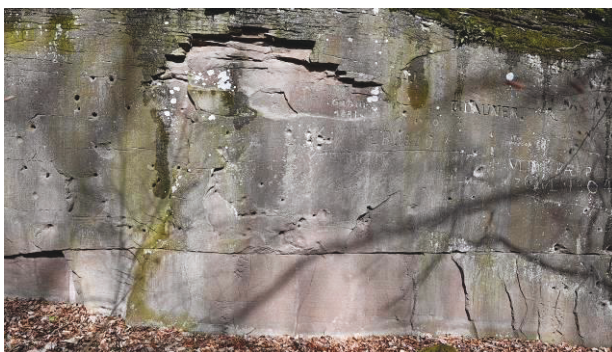
**Figure 4.** Stone wall with graffiti, bullet holes and a big spalled part.

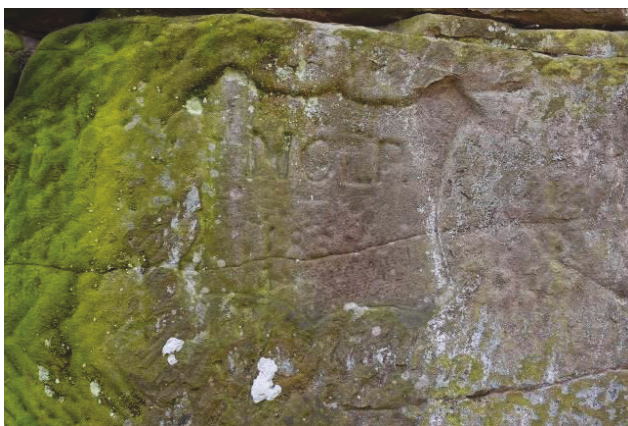
**Figure 6.** Almost illegible graffiti due to biological coating.

The high resolution scanning was carried out with an Artec EVA scanning device using Artec studio 15 software. The settings ensure a 3D point distance up to 0.5 mm. The resolution was chosen to ensure that even filigree scratchings are properly recorded. The recording was performed either while the area of interest was in shadow, or using an umbrella to shield the surface from bright sunlight. The filigree and organic structures on parts of the inscriptions and graffiti covered with moss and moist areas were difficult to capture (Fig. 6). Approximately 30 vulnerable inscriptions and graffiti have been documented using

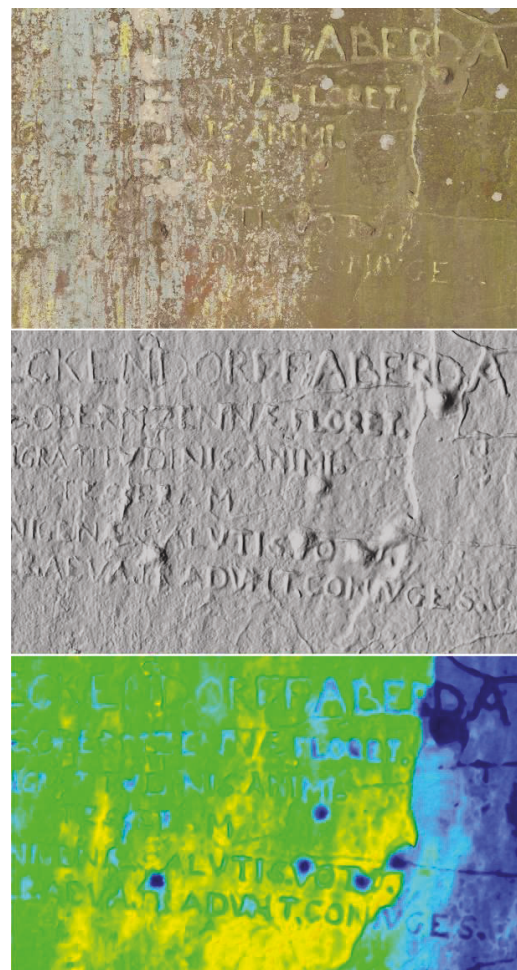
**Figure 9.** Detail orthophotos of the SLS-data of a memorial inscription on the western wall (wall 2) to enhance the readability of the inscriptions (from top to bottom): textured 3D model, textureless 3D model with raking light, depth map from a 3D comparison to a base-level (also usable for future monitoring).

Another way to better visualise the inscriptions and graffiti is a 3D-surface comparison to a plane surface that is displayed in a false colour image. The 3D comparisons were created using GOM Inspect 2022 (Zeiss Quality Suite 2022) (Fig. 9). This methodology could also be used in the future, to monitor the decay process of the site.

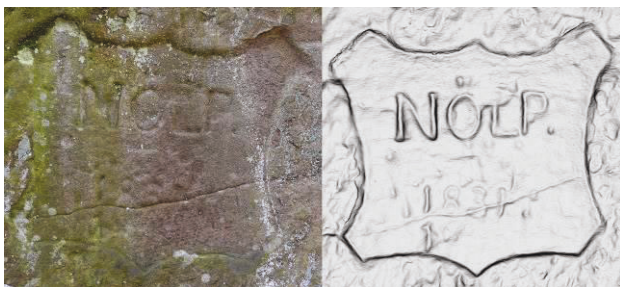
**Figure 15.** Comparison of almost illegible graffiti on the left (photograph) and, on the right, virtually illuminated 3D surface model.

An example of graffiti and inscriptions with nearly unreadable characters and dates is located on wall 2 and engraved in an emblem: the characters in the first line are NÖLP, which can be identified in the photograph, but the date below is indecipherable. Using the textureless 3D surface model it can easily be read as 1831 (Fig. 15).
